Bodie Island Coast Guard Station Historic Structure Report

Cape Hatteras National Seashore
Bodie Island Coast Guard Station
Historic Structure Report

2005

By
Joseph K. Oppermann - Architect, P.A.
P.O. Box 10417, Salem Station Winston-Salem, NC 27108
336/721-1711 FAX 336/721-1712
joskopp@mindspring.com

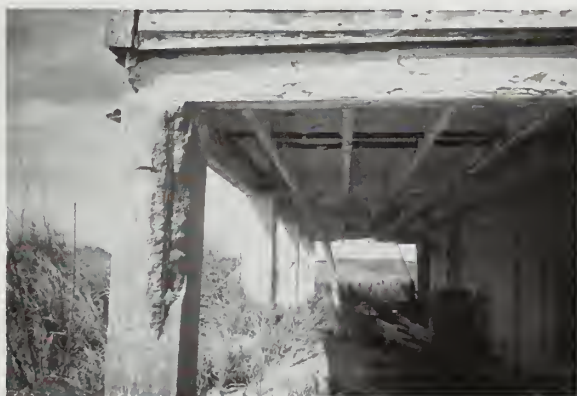
Figure C-4 Porch foundation and floor framing

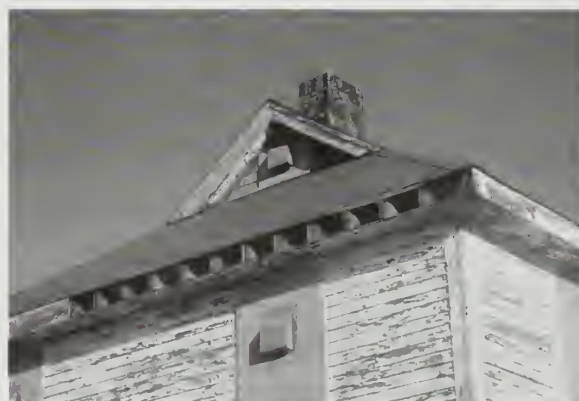
Roof & Rainwater Collection/Dispersal: The station has asphalt shingle roofing on all roof surfaces; it is in relatively good condition. No gutters or downspouts are in place, though early photographs show them installed on the porch roof and roof of the main block. Some fascia boards of the main block are currently missing, including an approximately 16 feet long section on the north elevation, and two sections totaling approximately 20 feet on the east elevation.

Figure C-5 Missing fascia board on the north elevation

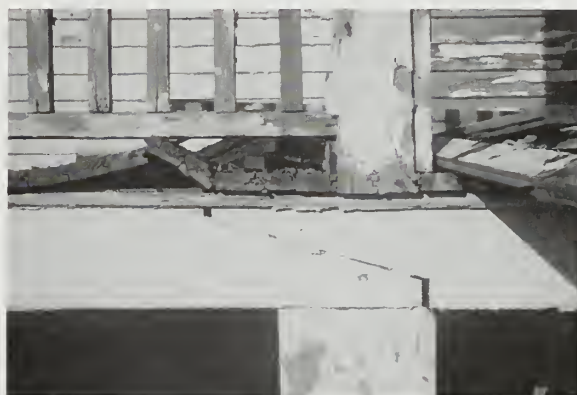
Porches: The first-floor wraparound porch on the south and west elevations is an original feature. The shallow pitch of the hip roof and concrete foundation piers of the porch remain unchanged. The south portion of the porch was enclosed at some time between 1956 and 1962. In 1962, stairs were built in their current location off the northernmost bay of the west section of the porch. Both the stairs and the exposed portion of the porch are in poor condition. Severely peeling paint has allowed access by water, causing the wood to swell and buckle, and rot has formed in numerous areas. The flooring in the south bay of the west section has collapsed.

Figure C-8 Buckling porch flooring and collapsed porch railings

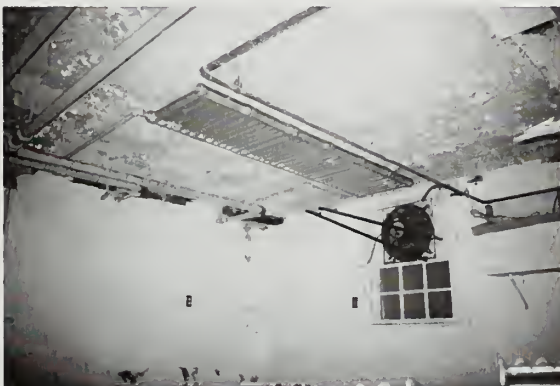
Figure C-12 Exhaust fan replaces top sash
